Stories of Success

In-Situ Repair at Oskarshamn 3: innovation and performance serving our customer for operational readiness

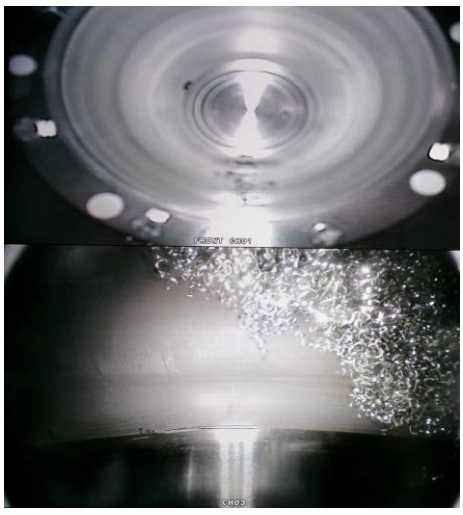
Camera of the mobile lathe

In collaboration with its partners, Framatome has developed in short time a self-propelled, mobile lathe—including a laser measurement system— as well as a pipe-internal manipulator serving as a carrier system for the welding head, inspection camera and cleaning system.
